Bourbanis Dam

NRCS EWP Path Forward

Pembina County Water Resource District
Board Meeting
5/19/2022

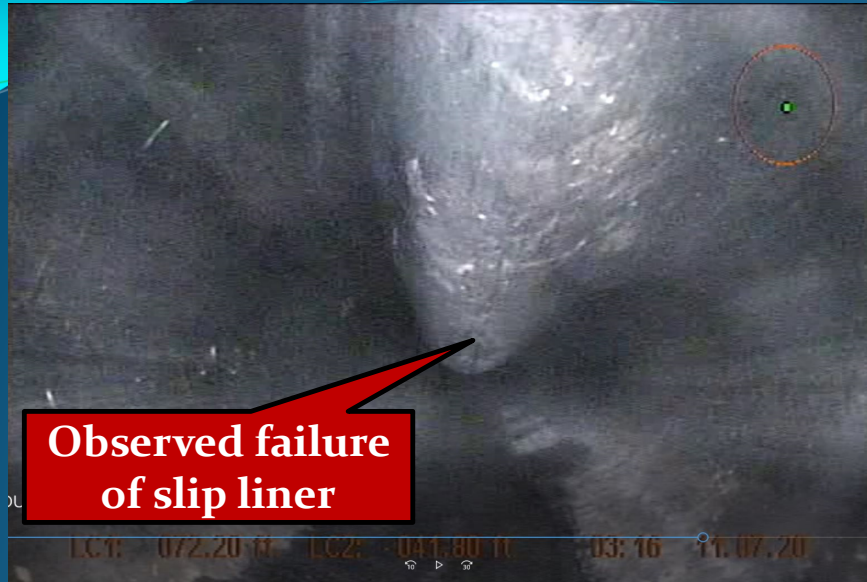
**Observed failure
of slip liner**

- Conduit slip lined due to failing as-built conduit.
- Observed failure of slip liner has been noted during recent inspections.
- Potential for continued degradation of slip liner during 2022 flood event (*unknown to the extent at this time*)
- Failed slip liner reduces hydraulic capacity of the principal spillway
- Increased potential risk of lateral flow through soil adjacent to conduit
- Non-conforming riser results in high potential for plugging and limits hydraulic efficiency

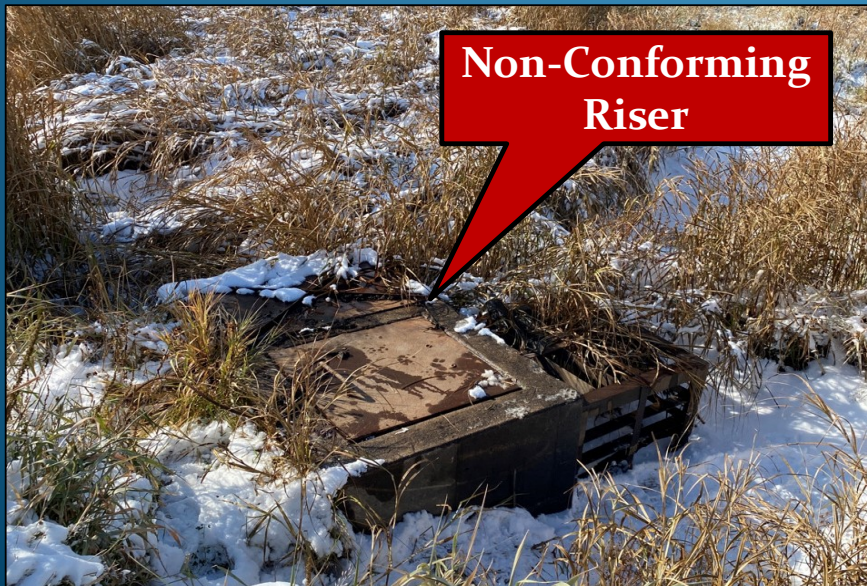
**Non-Conforming
Riser**
